## Building Envelope Performance

### 5.1 Doors

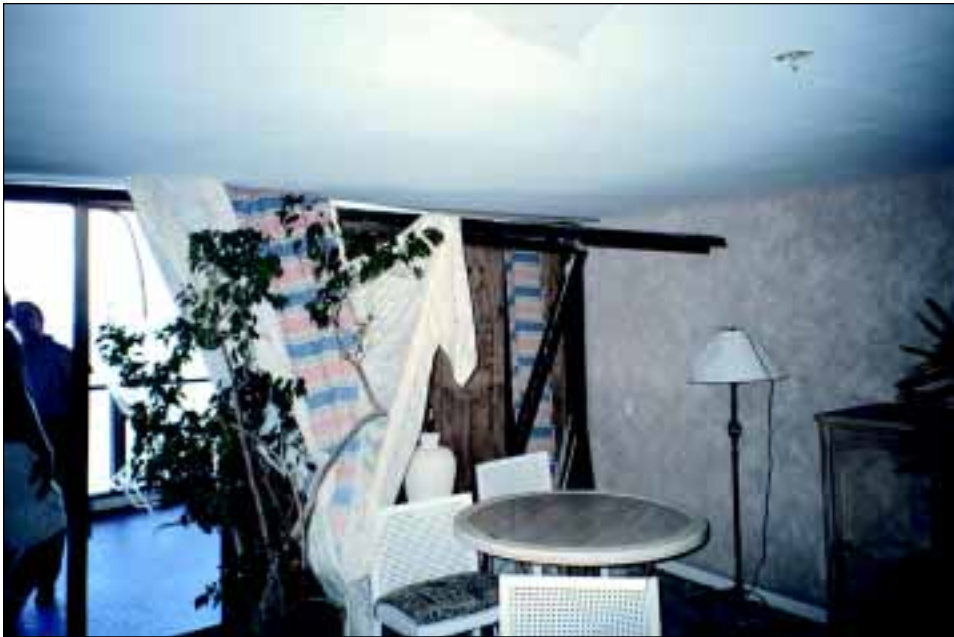
**FIGURE 5-1** This sliding glass door and window assembly in a hotel room was 7' 2" high and 14' long. The head of the frame was attached with four pairs of #12 or #14 screws in plastic sleeves. The sleeves pulled out and the entire length of the frame was pushed inward, resulting in substantial glass breakage. This building was located on Isla Verde in San Juan.

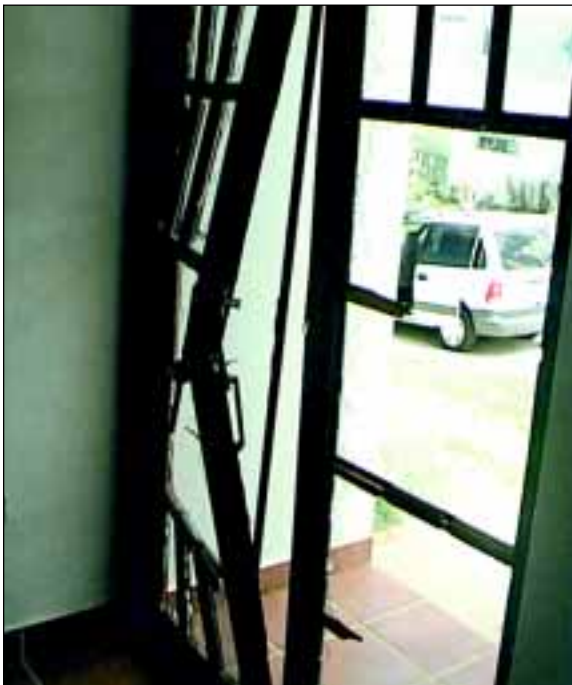
**FIGURE 5-2** Missiles broke this wood/glass door and several adjacent window panes.

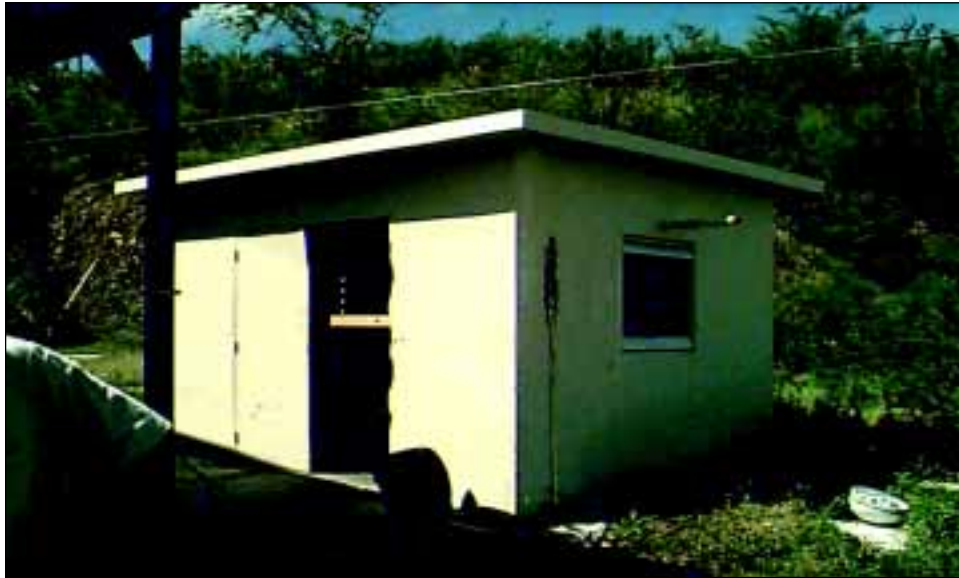
The BPAT observed few instances of door or door frame failure. However, Figure 5-3 illustrates a metal door that was blown out when the frame anchors pulled out. The door was blown out after the louvered window on the building failed, allowing an increase in internal air pressure.

**FIGURE 5-3** A missile traveling right to left struck the window louver. The door frame was attached by fasteners into wooden plugs that had been set into holes drilled into concrete. Once the louver failed, the door frame failed.

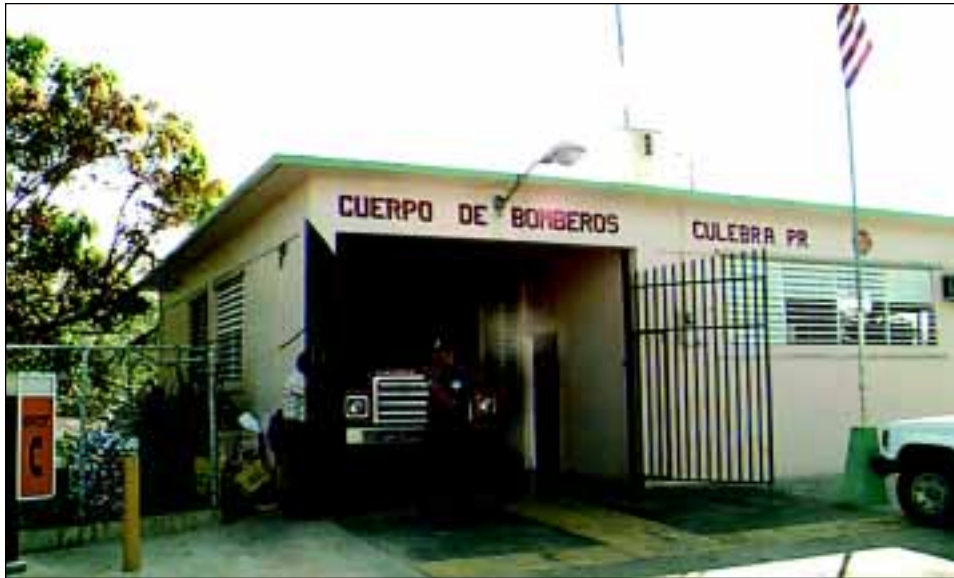
**FIGURE 5-4** The security grille on this fire station offers greater wind performance reliability than a solid door because very little air pressure is applied to it during high winds. This fire station is located on the island of Culebra.

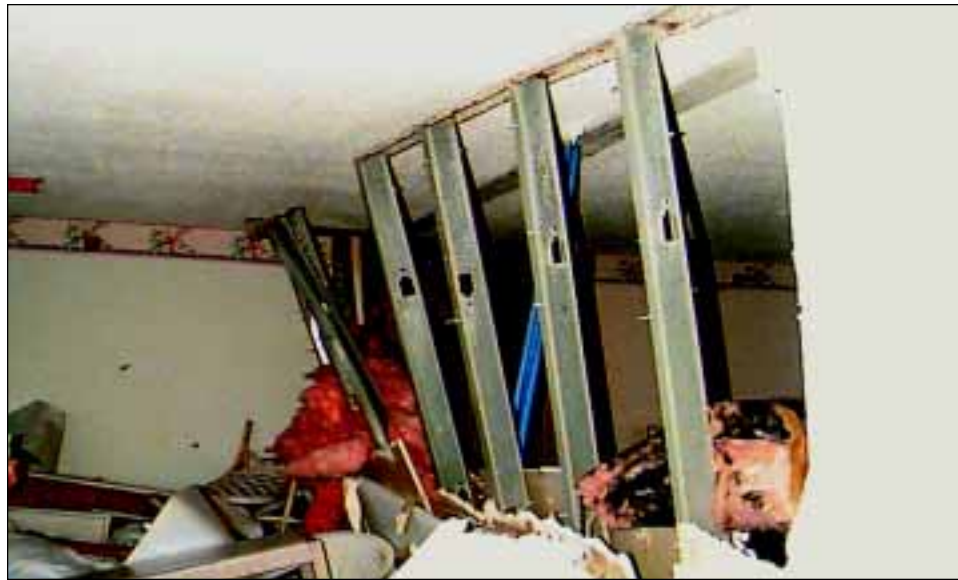
**FIGURE 5-5** The gypsum wallboard was blown off this interior partition after the exterior non-load bearing wall was blown away, allowing an uncontrolled, rapid increase in internal air pressure.

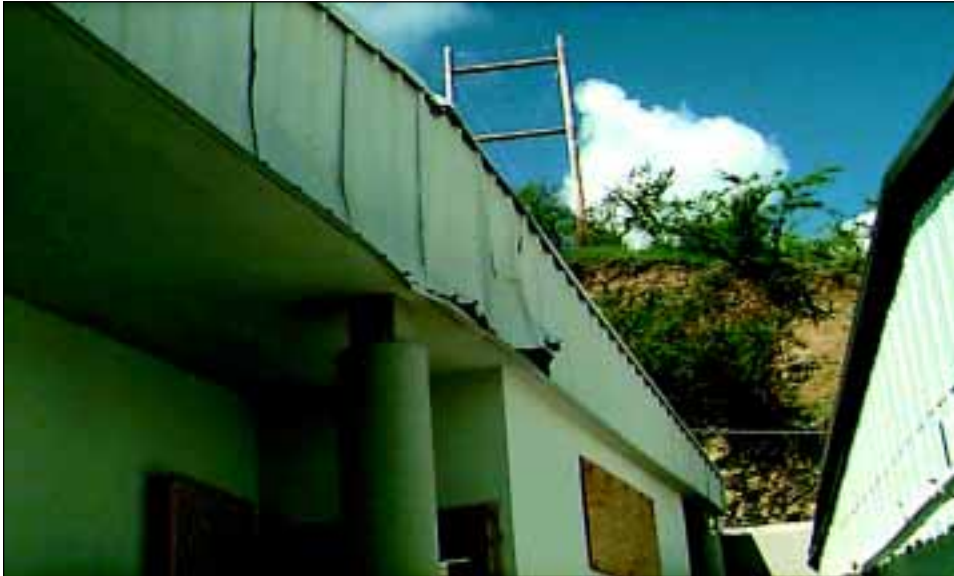
Metal panels over light-gauge steel framing were the most common non-load bearing walls observed. The BPAT noted the loss of metal panels due to an insufficient number of panel fasteners. In one instance, metal panels at the gable end of a building were damaged when a rooftop water tank blew off and struck the side of the building (Figure 5-6).

**FIGURE 5-6** Rain entered this hospital on Culebra after a water tank struck the metal wall panels.

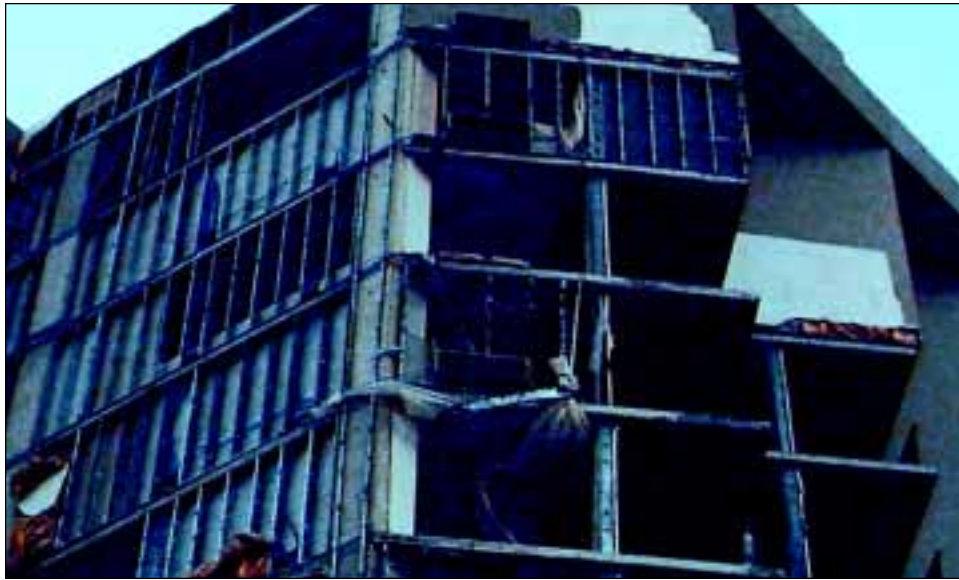
A problem with EIFS at an ocean front high-rise was also observed. It appeared that the exterior wall stud tracks were insufficiently attached (Figure 5-7). Failure of the wall system resulted in substantial interior damage.

**FIGURE 5-7** This EIFS wall system was composed of synthetic stucco over 1-in thick expanded polystyrene insulation (EPS) over a layer of exterior gypsum board over 6-in deep steel studs, with a layer of gypsum board on the interior side of the studs. Fiberglass batt insulation was installed within the stud cavity. There were several different planes of failure. Insufficiently attached stud tracks appeared to have been the initial failure point. This building was located on Isla Verde.

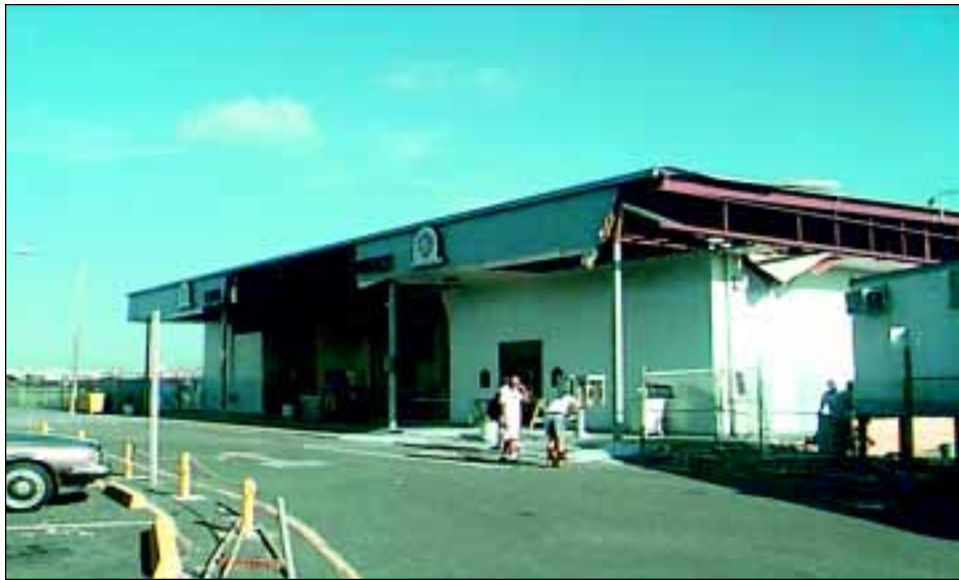
The BPAT observed two buildings with composite wall panels composed of thin metal sheets bonded to a cardboard honeycomb core. The panels were attached with screws from the metal framing into the interior metal skin. On one building, the panels were also used as the soffit. In both buildings, the panels blew off because of insufficient strength of the connections between the composite panels and the structural frame of the building (Figure 5-8).

**FIGURE 5-8** Several composite panels blew off from the fascia and soffit of this building at the airport on Isla Grande. Although several screws were installed, the metal into which they were driven was too thin to develop sufficient blow-off resistance to withstand the wind loads.

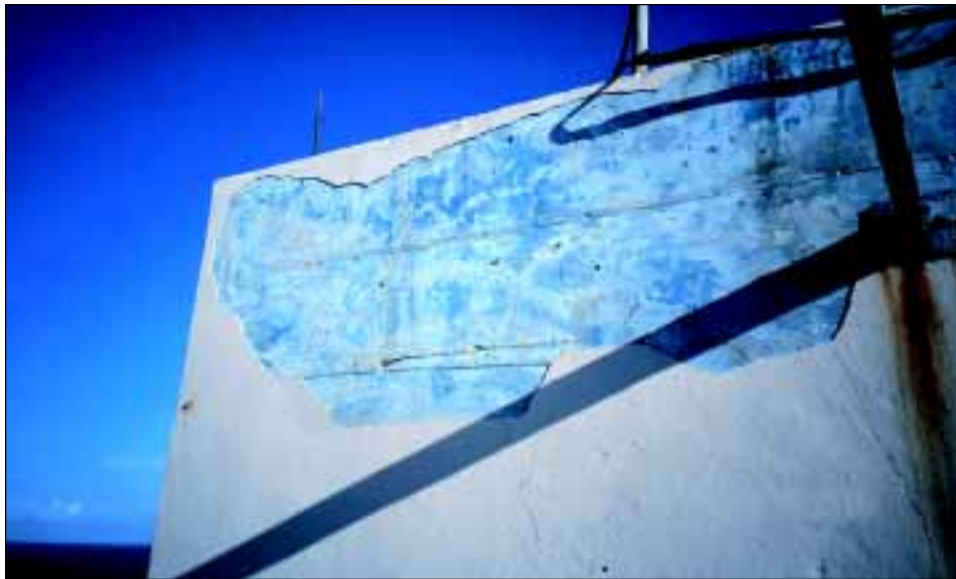
The loss of stucco applied over cast-in-place concrete was the most common problem observed with wall coverings (Figure 5-9). Rather than cast concrete with a relatively flat and smooth surface, traditional practice in Puerto Rico has been to cast the concrete rough, as shown in Figure 5-10, and apply a stucco finish.

**FIGURE 5-9** The stucco was blown off the corner area of this wall, where the suction pressures were high. Note the rough texture of the concrete.

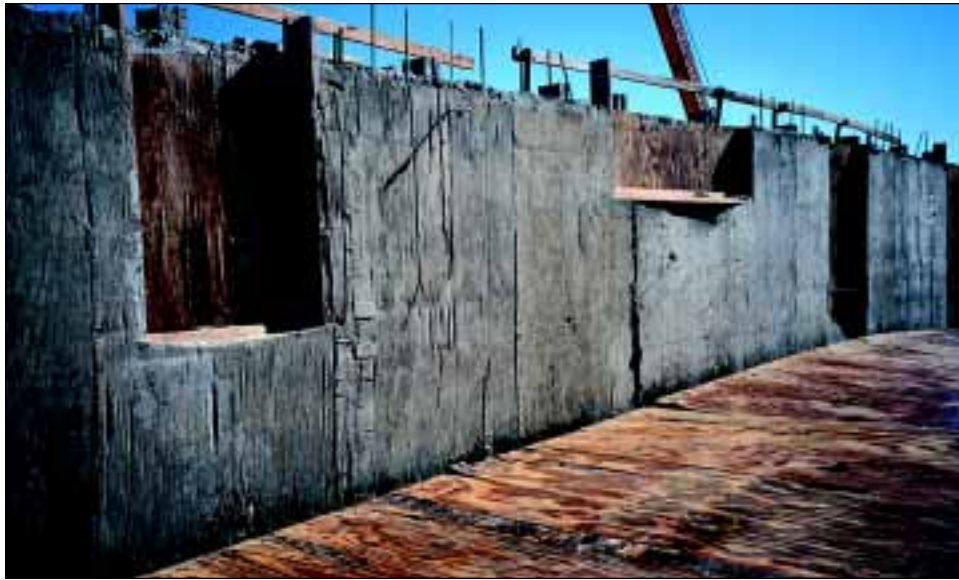
**FIGURE 5-10** This house is under construction. The surface of the concrete is very rough because the plywood form (which is lying down on the ground) was used repeatedly. The rough texture will be compensated for with a stucco surfacing.

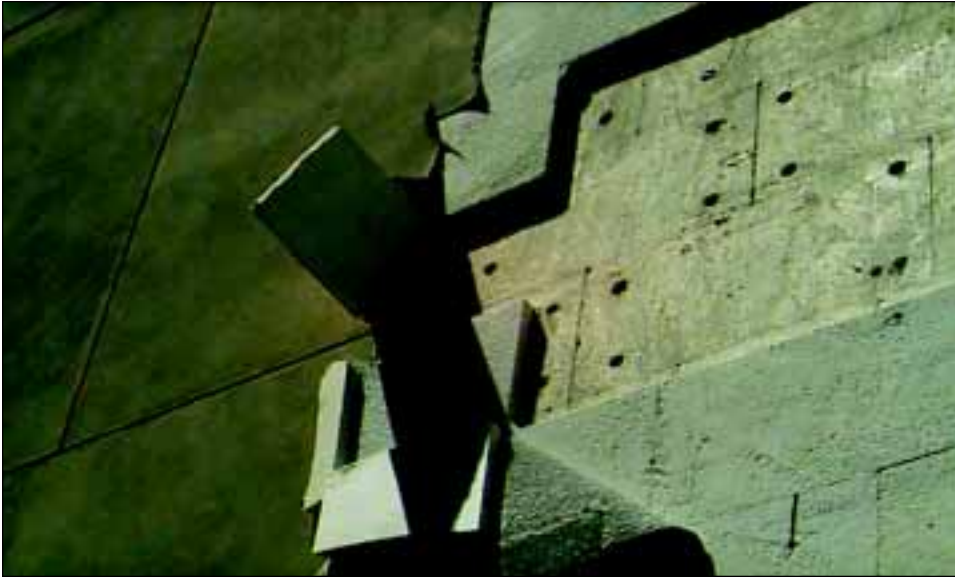
**FIGURE 5-11** At this EIFS covering, the synthetic stucco appeared to be well-adhered to the outer EPS layer, but there appeared to be minimal bonding between the two EPS layers. In at least the lower portion of the wall, the first layer was attached with mechanical fasteners deeply recessed into the foam. The delamination occurred near the corner of the building, where the suction pressures were high.

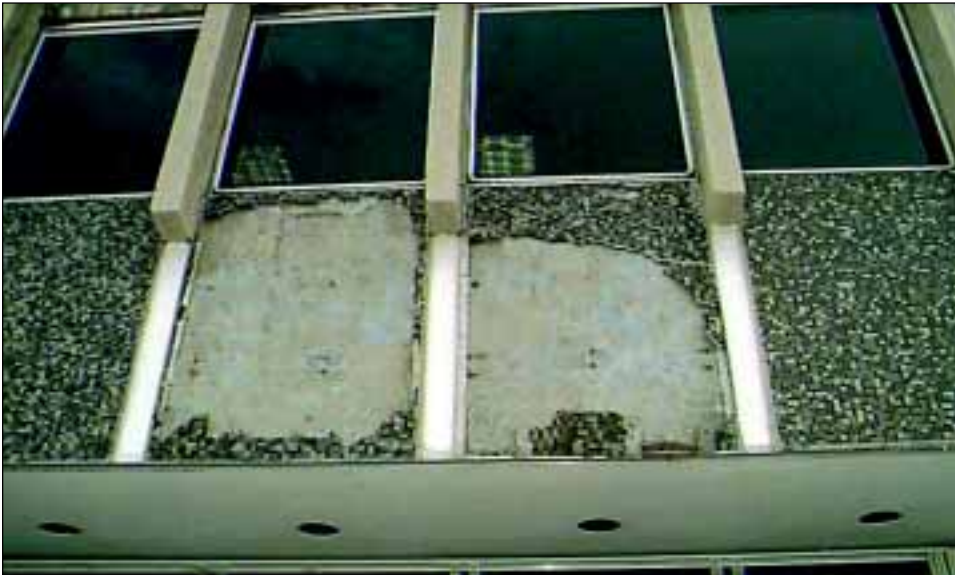
**FIGURE 5-12** A mortar skim coat was applied over the concrete, and the ceramic tiles were set in to the mortar. The primary failure plane was between the mortar and concrete.

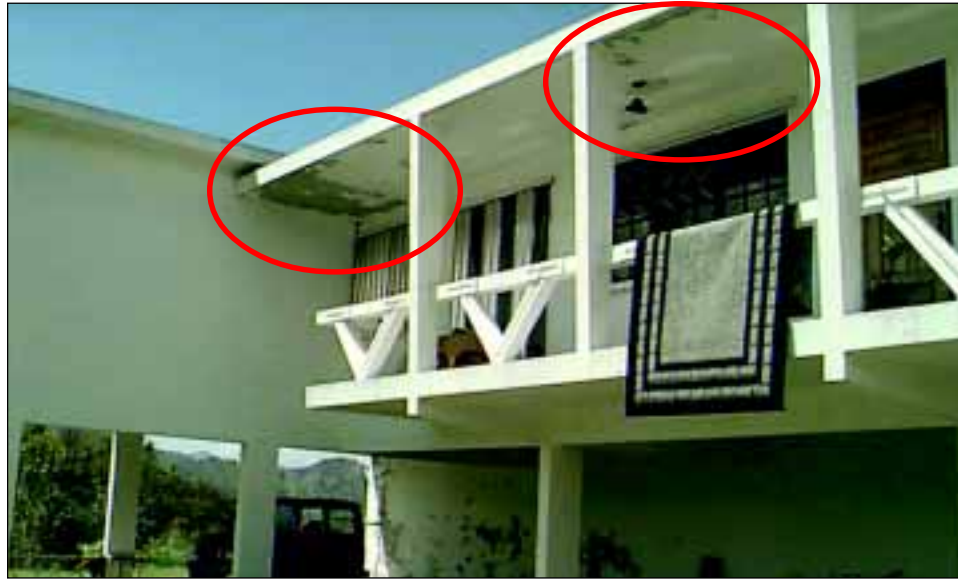
**FIGURE 5-13** This house was located on a mountain top that experienced very high wind conditions. The paint scoured off at some of the soffit areas and along the recessed wall.

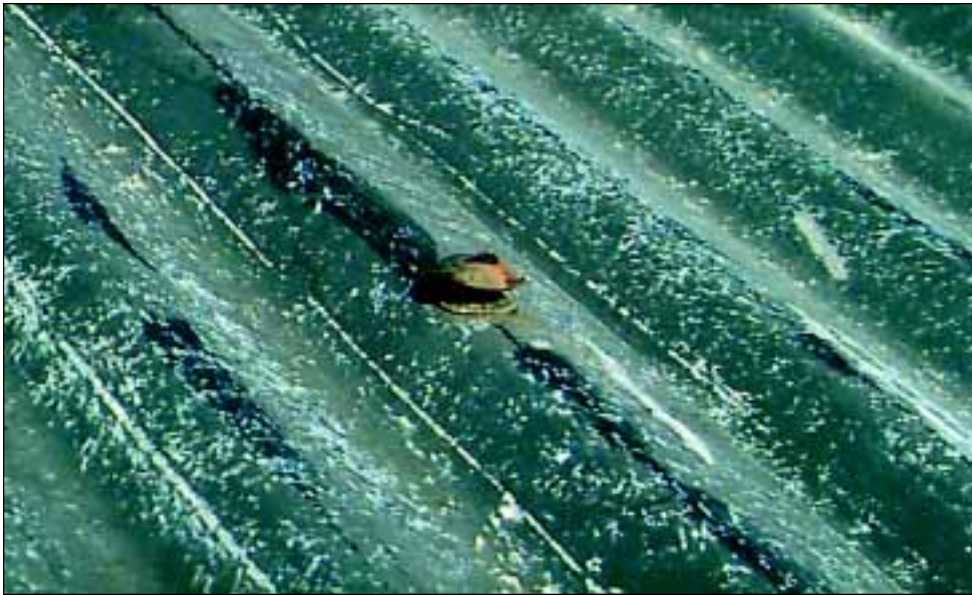
**FIGURE 5-14** The nail attaching this corrugated metal panel partially backed-out. Screws are much more resistant to back-out. Nail back-out is a problem with metal panel systems because of the large number of load cycles and large amount of deformation the panels can experience during a hurricane. Elsewhere on this roof, some of the panels were blown off.

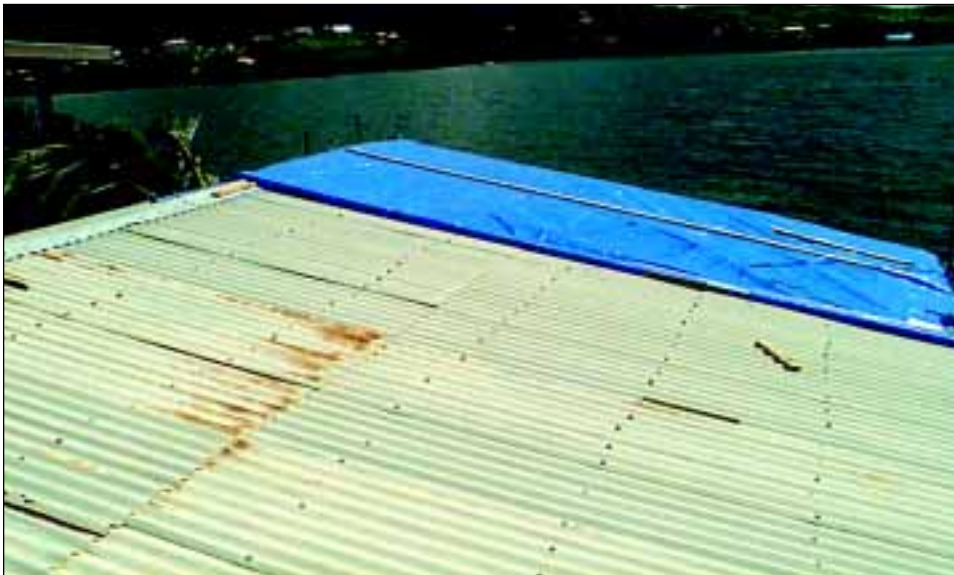
**FIGURE 5-15** Only a single row of fasteners were installed along the eave and along each side of the ridge. The side laps are insufficiently attached and are lifting in a few areas. The end lap is too far away from the first row of fasteners—another nailer should have been installed. Clips between the joists and wall were retrofitted prior to the hurricane; however, enhanced attachment of the metal roofing was not performed as part of that work. As a result, several of the metal panels were blown off.

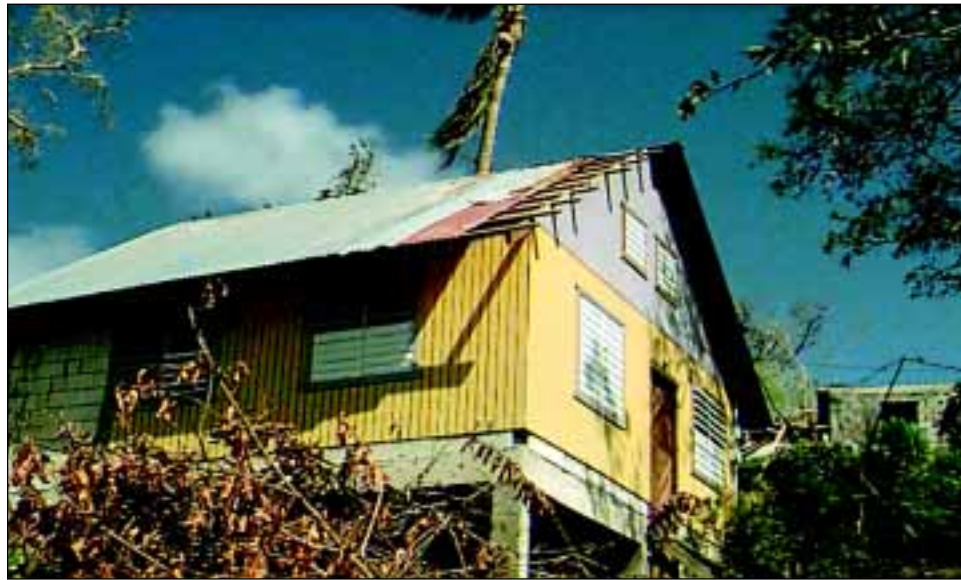
**FIGURE 5-16** The metal panels along this rake were insufficiently fastened. A framing member was not run up the rake.

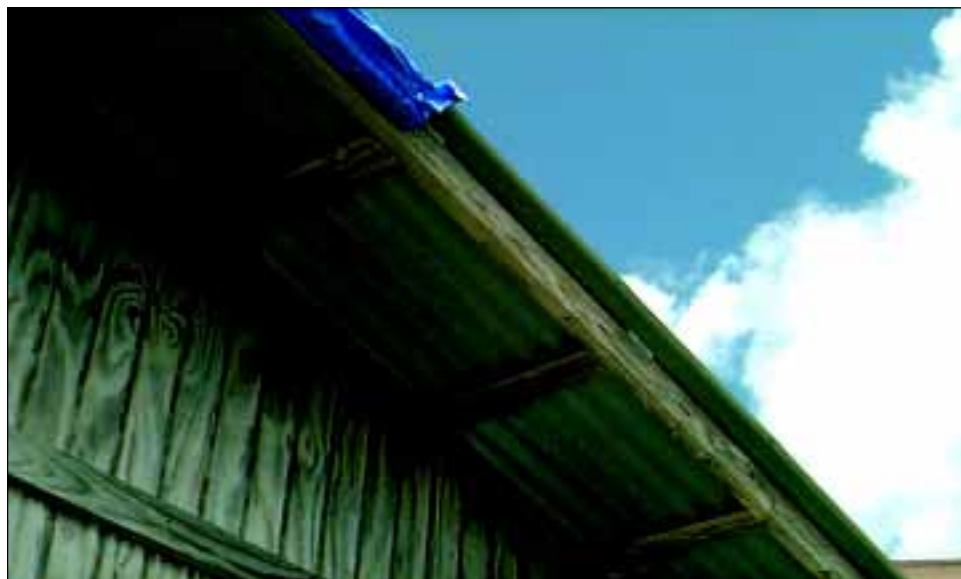
**FIGURE 5-17** At this house, a framing member was run up the rake, which allowed the metal panels to be fastened between the nailers (purlins). However, the rake member must have sufficient strength to resist design uplift loads, which does not appear to be the case with this member. Rather than installing a metal edge flashing, these metal panels simply were cantilevered beyond the rake framing, providing a loose edge that is susceptible to lifting and peeling during high winds. Other deficiencies that are noted in this photograph include incorrect nailing of roof material to rake member and inadequately sized and spaced nailers.

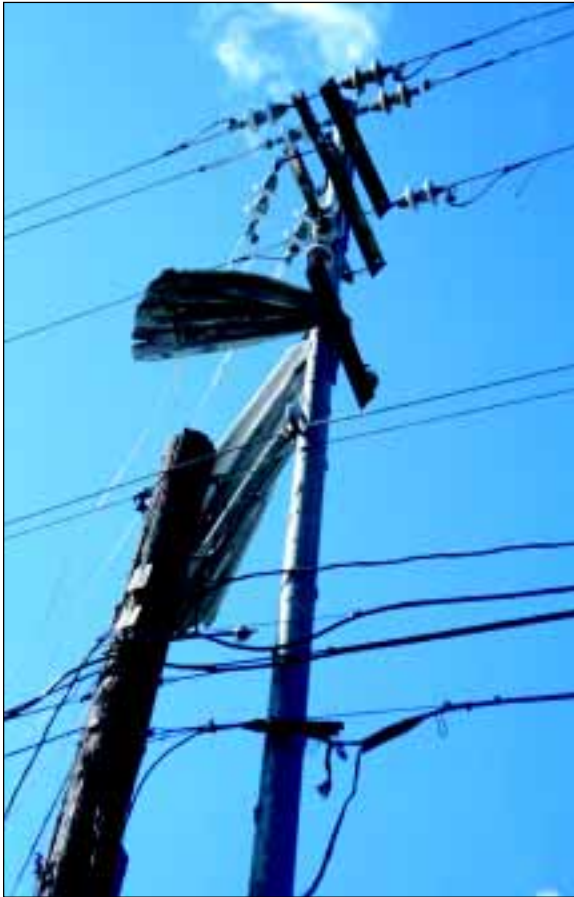
**FIGURE 5-18** Corrugated metal panel wrapped around a power pole.

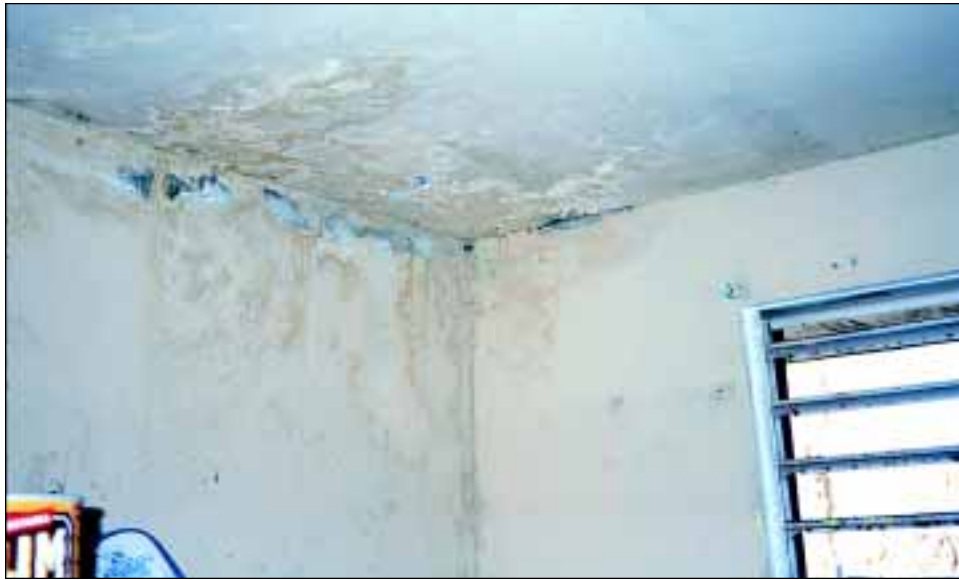
**FIGURE 5-19** This concrete roof deck did not have a roof covering. During the hurricane, water entered the house through the deck. The concrete deck and CMU walls were skimmed with a skim coat of plaster. This house has Miami windows.

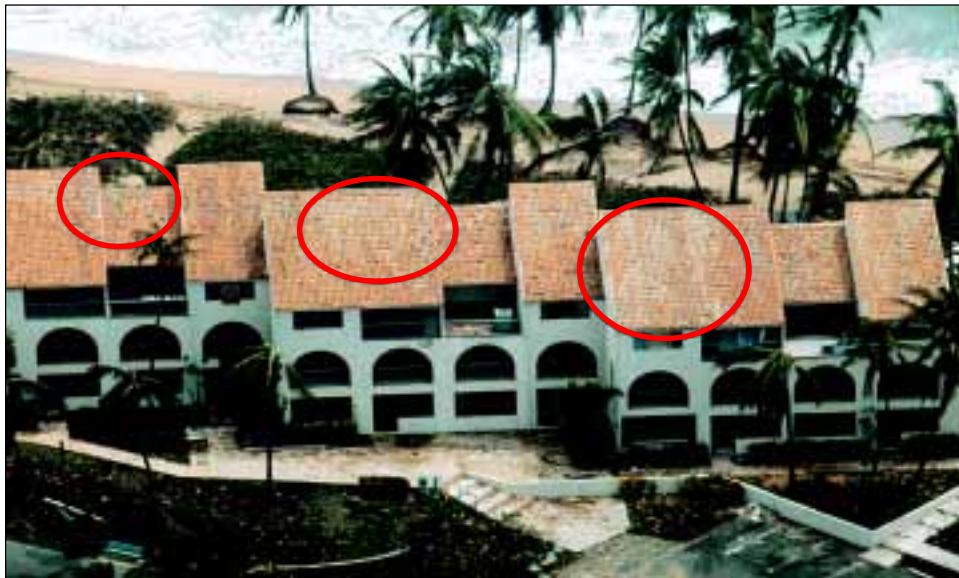
**FIGURE 5-20** These tiles were heavily damaged, although the wind speed at this location was not very high. As can be seen in the foreground, the roof covering generated a substantial number of missiles. Because of the relatively low wind speed, the tile debris did not travel very far.

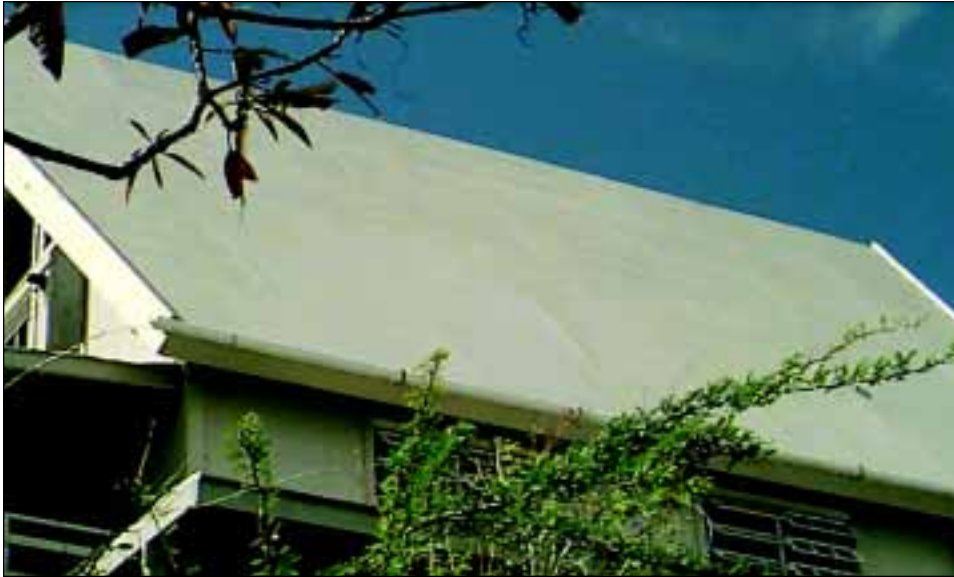
**FIGURE 5-21** This house had a liquid-applied membrane over plywood roof sheathing. This type of roof system typically offered excellent wind performance provided the plywood does not lift. This house was located on the island of Culebra.

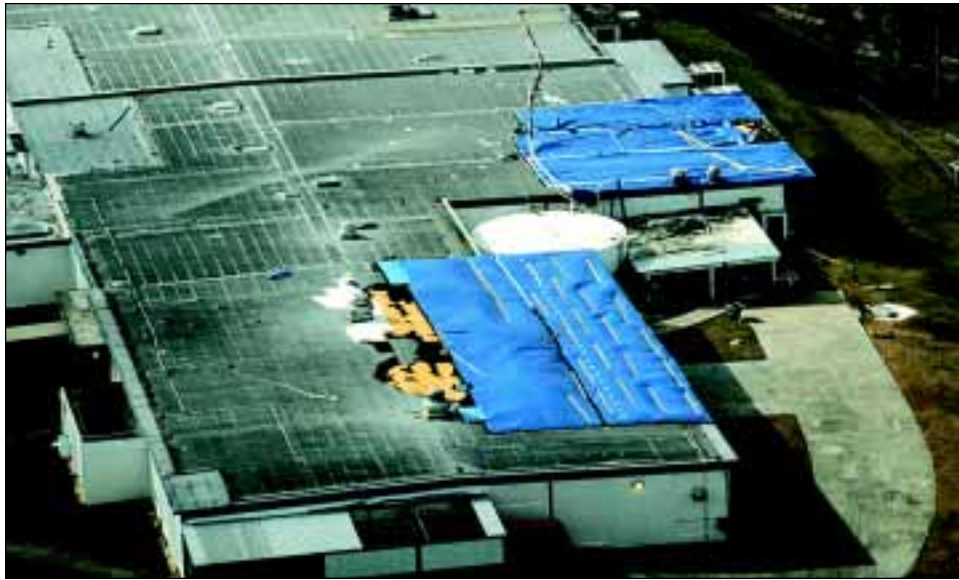
Several built-up roofs experienced membrane lifting and peeling. Since these roofs were not generally exposed to very high winds, damage usually was limited to corner areas, rather than complete loss of the roof covering (Figure 5-22).

**FIGURE 5-22** This built-up membrane had a mineral surface cap sheet. Because of the roof covering damage, this manufacturing facility on the island of Culebra was shut down for approximately two weeks after the hurricane. This building also experienced roof damage during Hurricane Hugo in 1989.

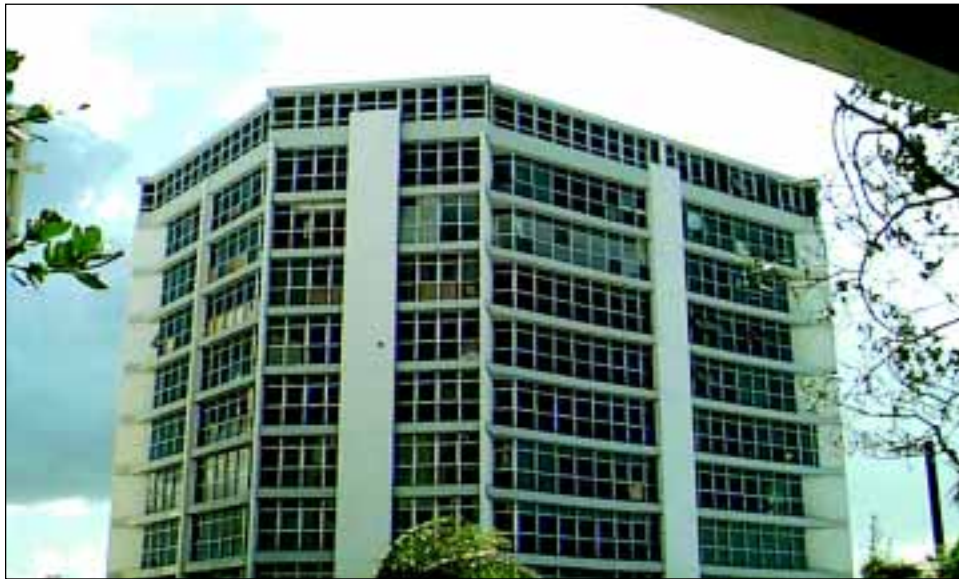
**FIGURE 5-23** The windows in this building were broken by aggregate from the built-up roof of a nearby building (Figures 5-24 and 5-25).

The building in Figure 5-23 had approximately 100 windows broken by aggregate that blew off of a built-up membrane roof across the street. Some panes were tempered glass (Figure 5-24) and others were annealed (Figure 5-25).

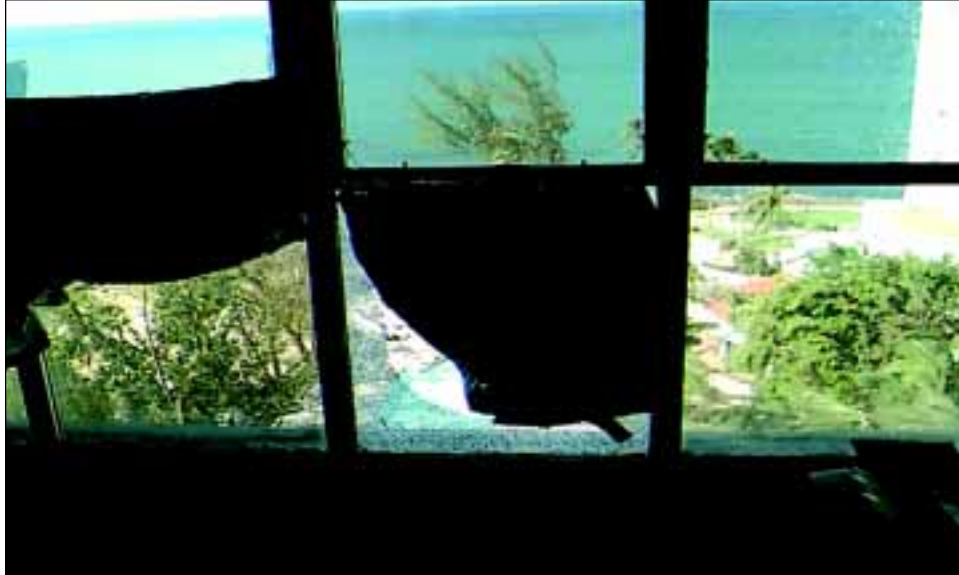
**FIGURE 5-24** When these tempered panes broke, they did not produce shards of glass, as did the annealed panes.

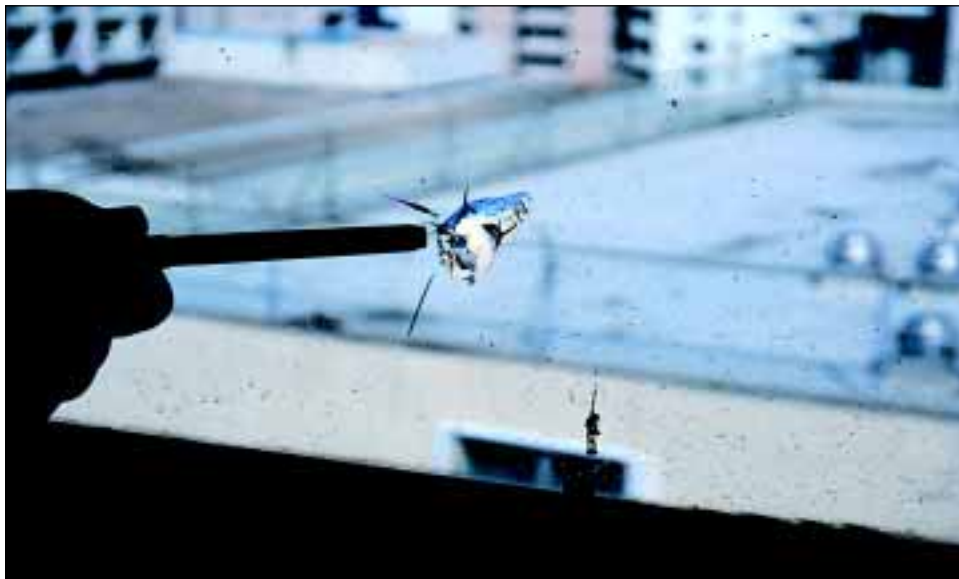
**FIGURE 5-25** Although some annealed panes broke into shards, others just broke at the impact point.

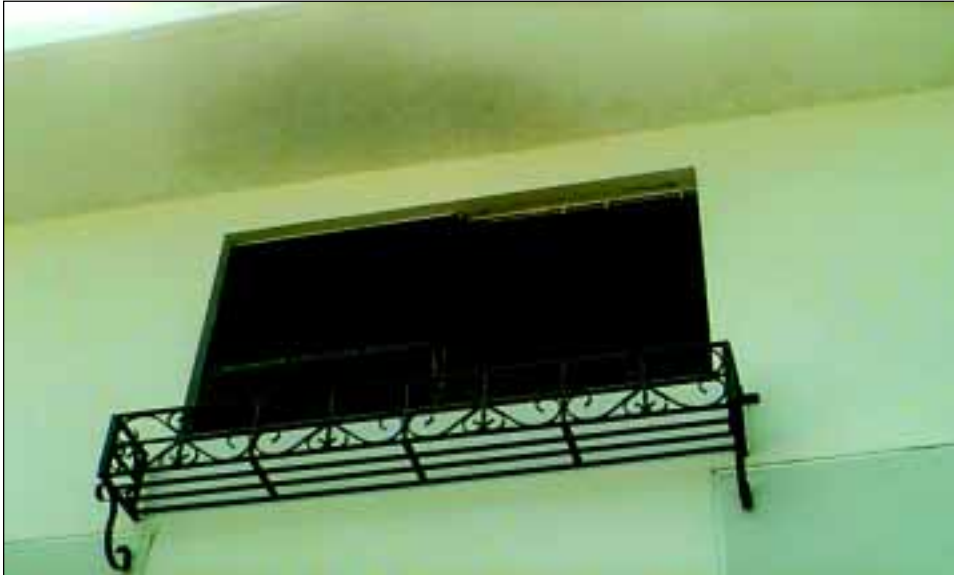
The window frame in Figure 5-26 was blown out by over-pressurization of the building interior when the building envelope was breached elsewhere in the building. Missiles broke the glass shown in Figures 5-27 and 5-28. The three buildings in these photos are all located near one another.

**FIGURE 5-26** Half of the window frame blew out. It was attached with two screws in plastic sleeves at the head, three screws at the jamb, and two screws at the sill.

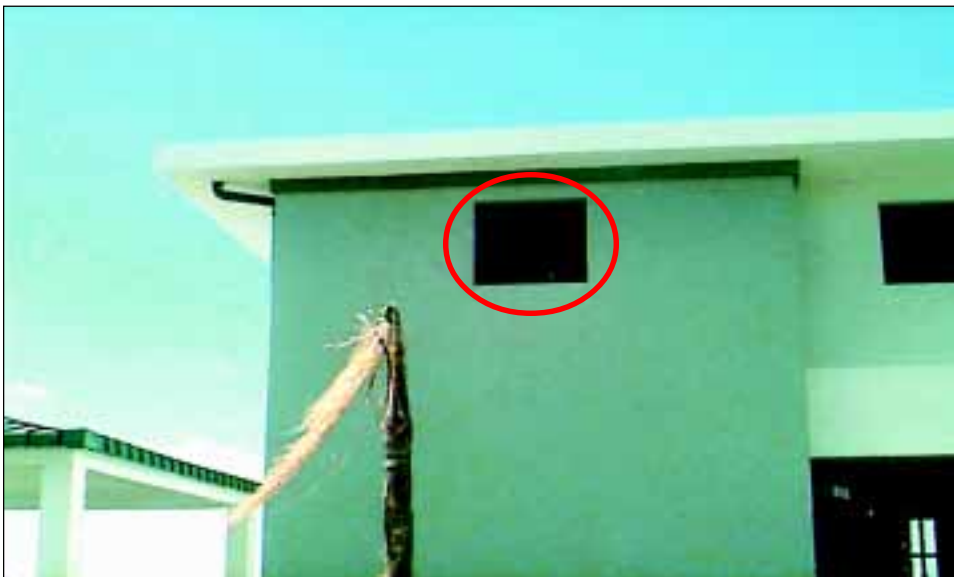
**FIGURE 5-27** One pane in this window was broken by a missile, perhaps from the palm in the foreground.

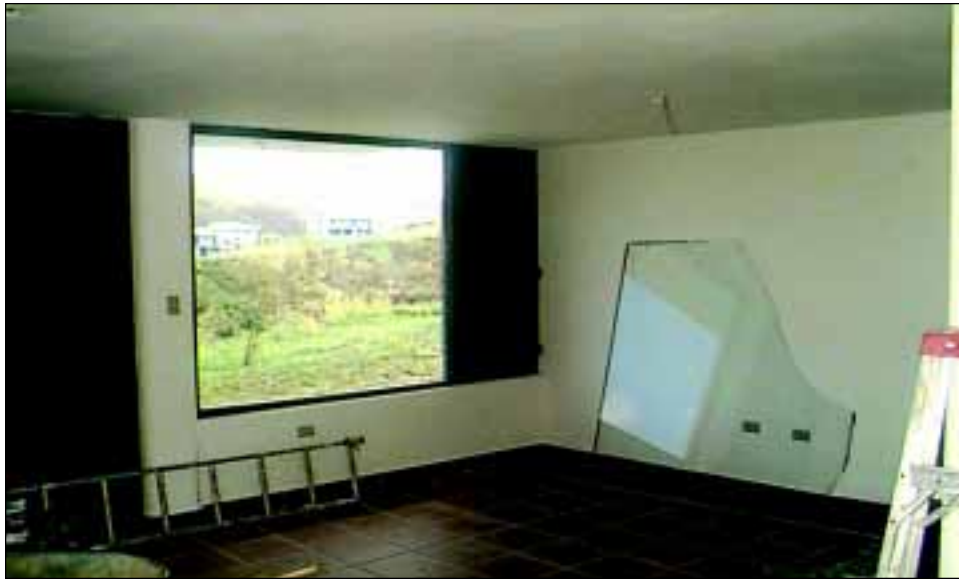
**FIGURE 5-28** This large window, which was removed and leaned against the wall after the storm, was broken by a missile, most likely a tree limb.

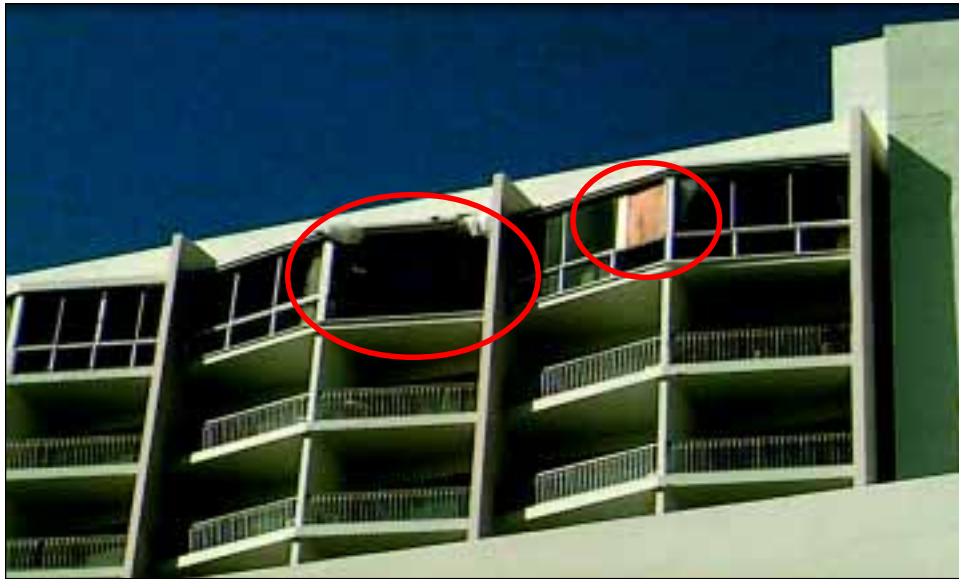
In Figure 5-29, some window frames in this mid-rise building were blown out while in other cases, just the glass was blown out. This appeared to be caused by negative pressure (suction).

**FIGURE 5-29** The glass and frames were blown out at the center room on the top floor. At the room to the right, one of the glass panes was blown out.

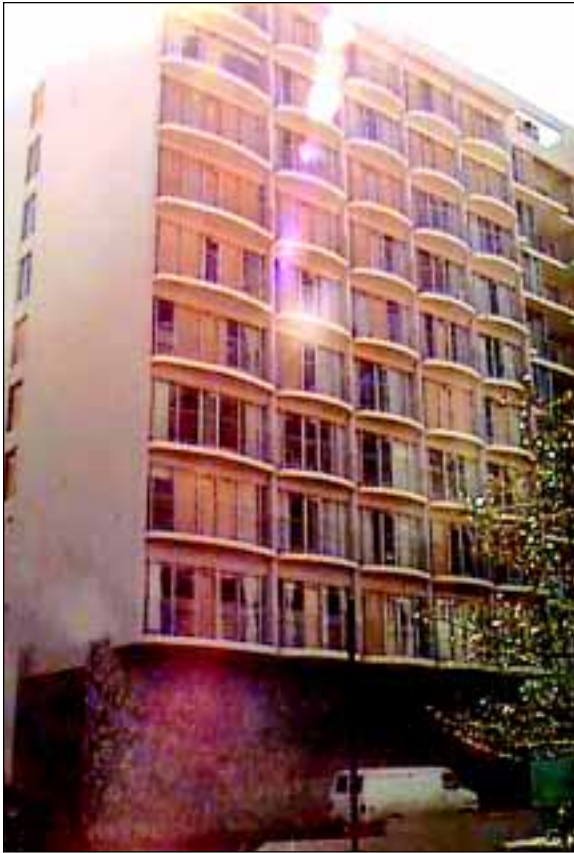
**FIGURE 5-30** Several window and glass door openings broke during the hurricane. They were subsequently covered with plywood (Figure 5-31).

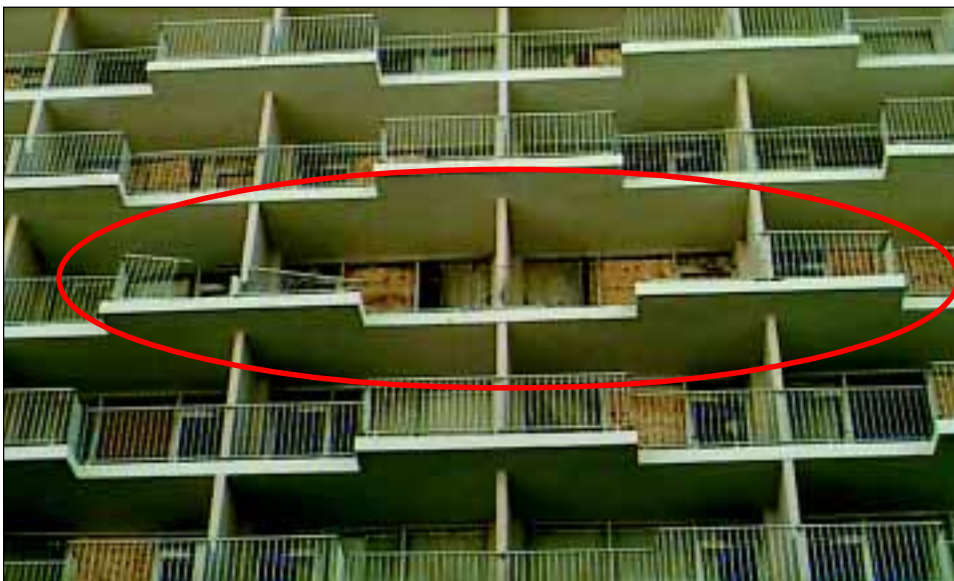
**FIGURE 5-31** High-energy missiles from a nearby building damaged several railings of this building.

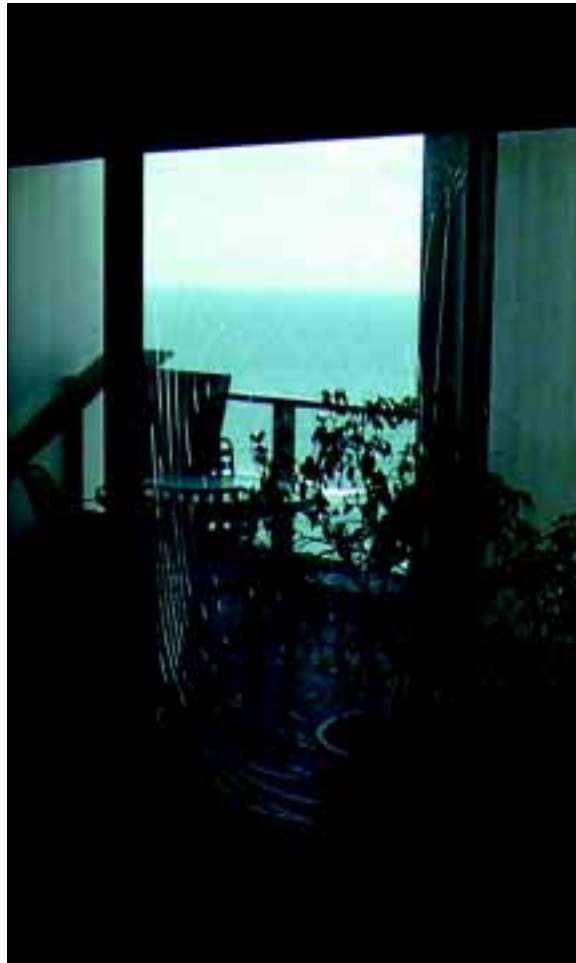
**FIGURE 5-32** The broken light in the center is laminated. A sliding glass door located to the left had tempered glass, which was blown out of the frame.

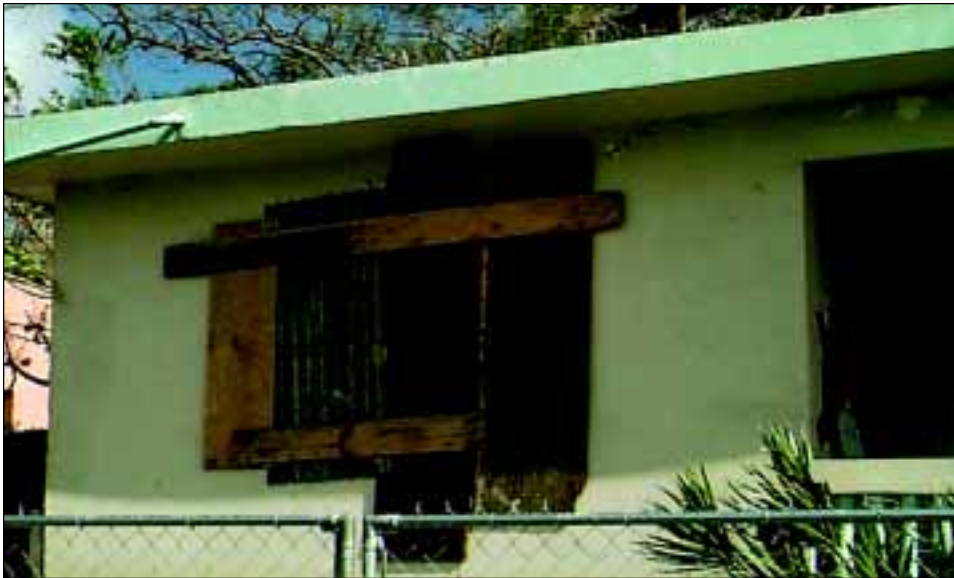
**FIGURE 5-33** A combination of boards and metal panel was used to construct this shutter. Unless shutters are well attached, they can blow off during high winds and become missiles themselves.

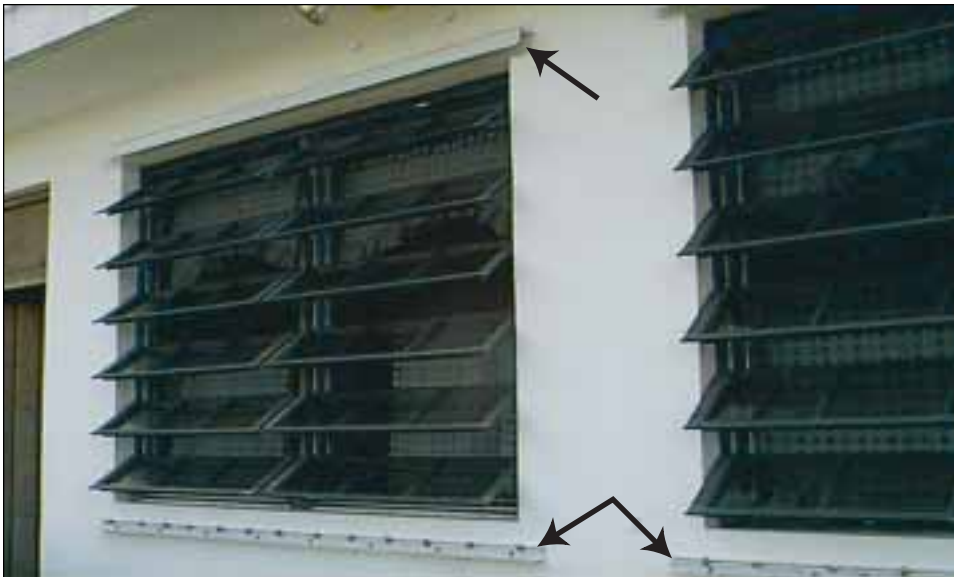
**FIGURE 5-34** These windows were equipped with permanent head and sill shutter tracks, which were attached to the wall with closely-spaced fasteners (Figure 5-35).

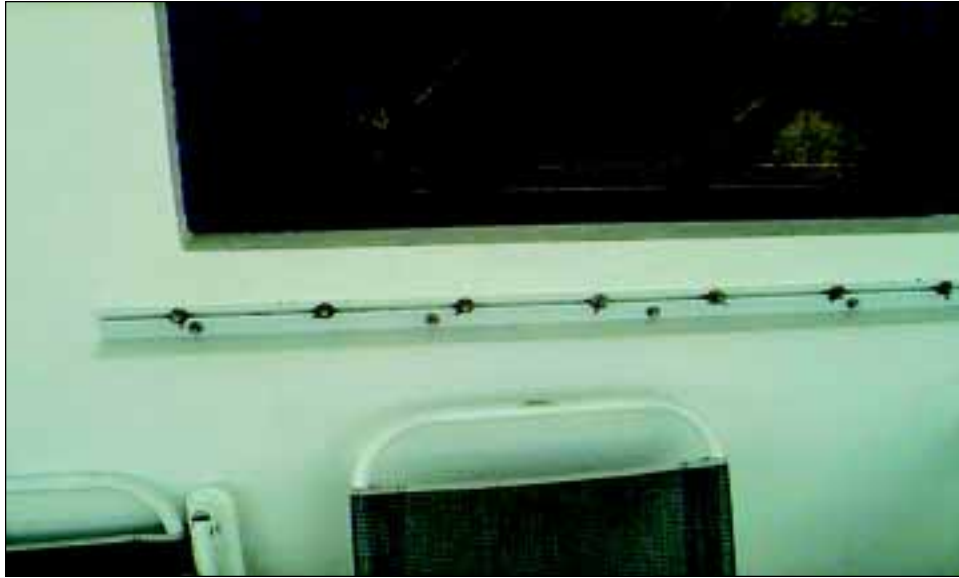
**FIGURE 5-35** Close-up of Figure 5-34. The steel shutter panels were designed to be locked into the track with wing nuts spaced 6-in on center, a more reliable attachment than that shown in Figure 5-36.

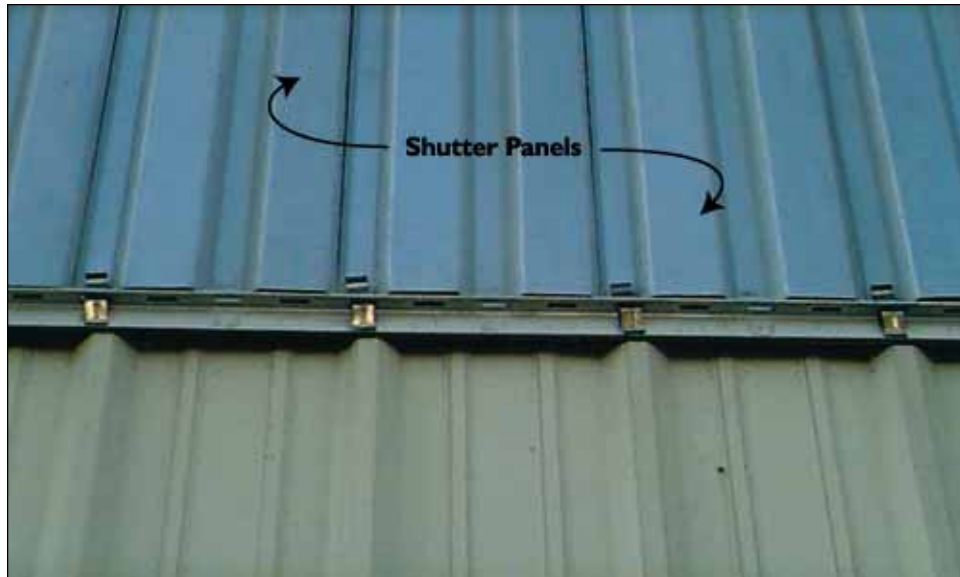
**FIGURE 5-36** Looking up at a shutter panel held in place by clips (a metal wall panel occurs below the shutter track). These clips were spaced 12-in on center. Clips are not as reliable as the bolted attachment shown in Figure 5-35.
